Effects of Land Treatments on Erosion and Vegetation on Range Lands in Parts of Arizona and New Mexico

H. V. PETERSON AND F. A. BRANSON

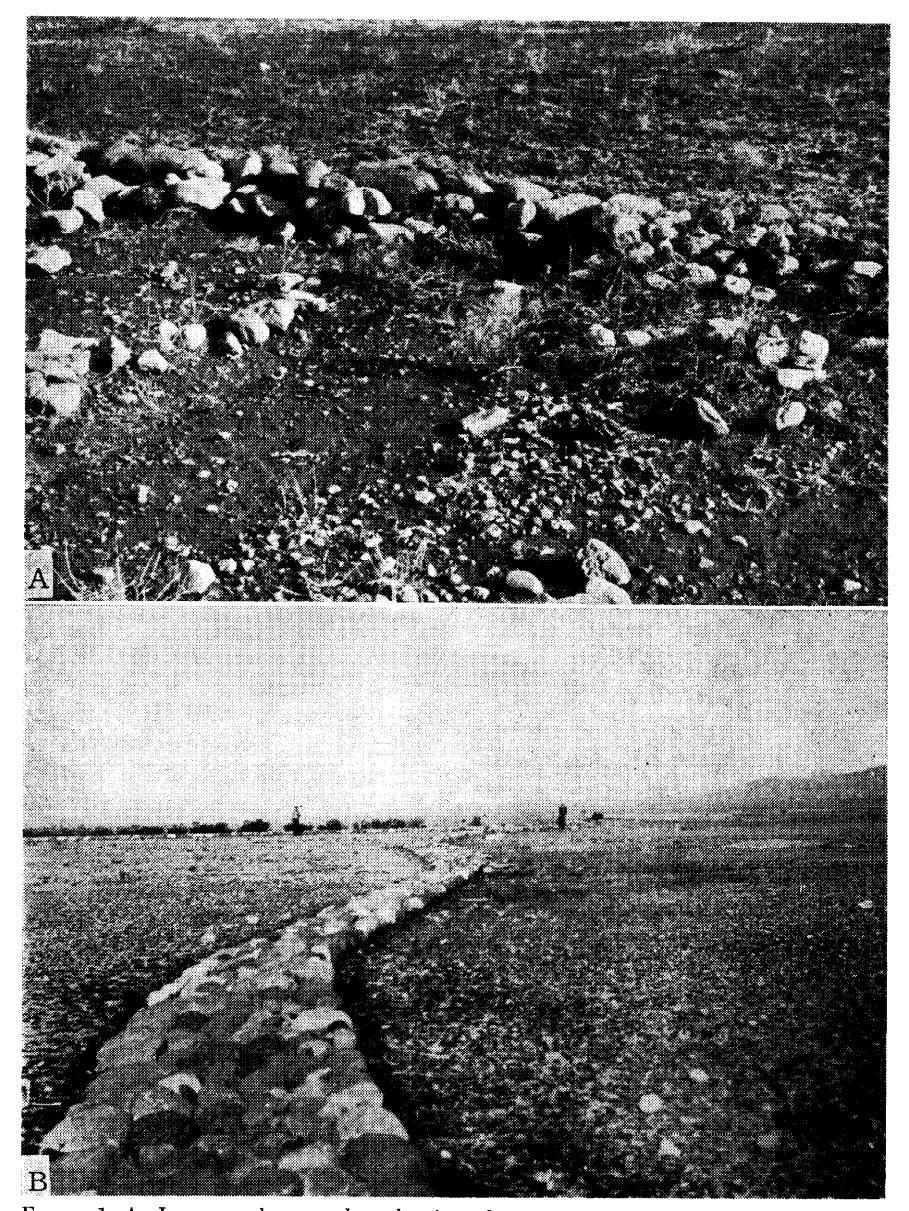
FIGURE 1. A. Loose rock spreader showing deterioration shortly after construction. Rodeo area, New Mexico.

B. Hand-placed rock spreader showing no deterioration 5 years after installation.

The loose rock spreaders were easily breached in a short period. The percentage of failures in the hand-placed types was much lower. "Cement worms" were effective in catching small amounts of sediment, but water plunging over the downslope side resulted in under-cutting and was the cause of occasional failures. These were often placed on vegetation types such as creosote bush that generally have low forage production potential. Although effective in catching sediment, brush spreaders proved highly vulnerable both to natural rot and to accidental and incendiary fire. Most of the brush spreaders disappeared within a few years.

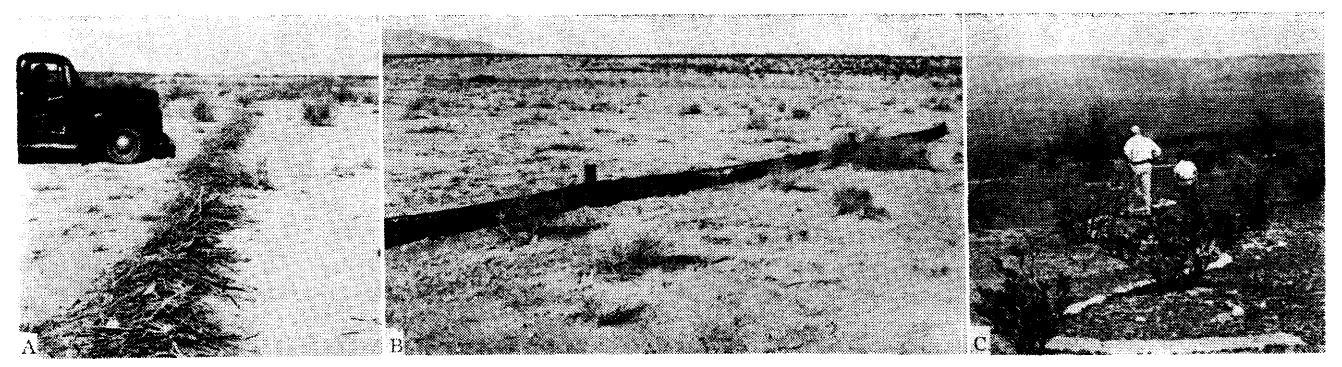
FIGURE 2. A. One of the few remaining brush spreaders on Freeman Flat in 1949.

B. Typical spreader of hog wire supported by cable and posts. Freeman Flat, 1949.

C. A "cement worm" water spreader near Fort Thomas, Arizona (1961). Little change in vegetation or sediment entrapment is apparent.

All of the wire spreaders were still in place in 1961, twenty-five years after construction. Gradual rusting of the wires and cables and some undercutting was apparent in a number of the structures examined in 1961.

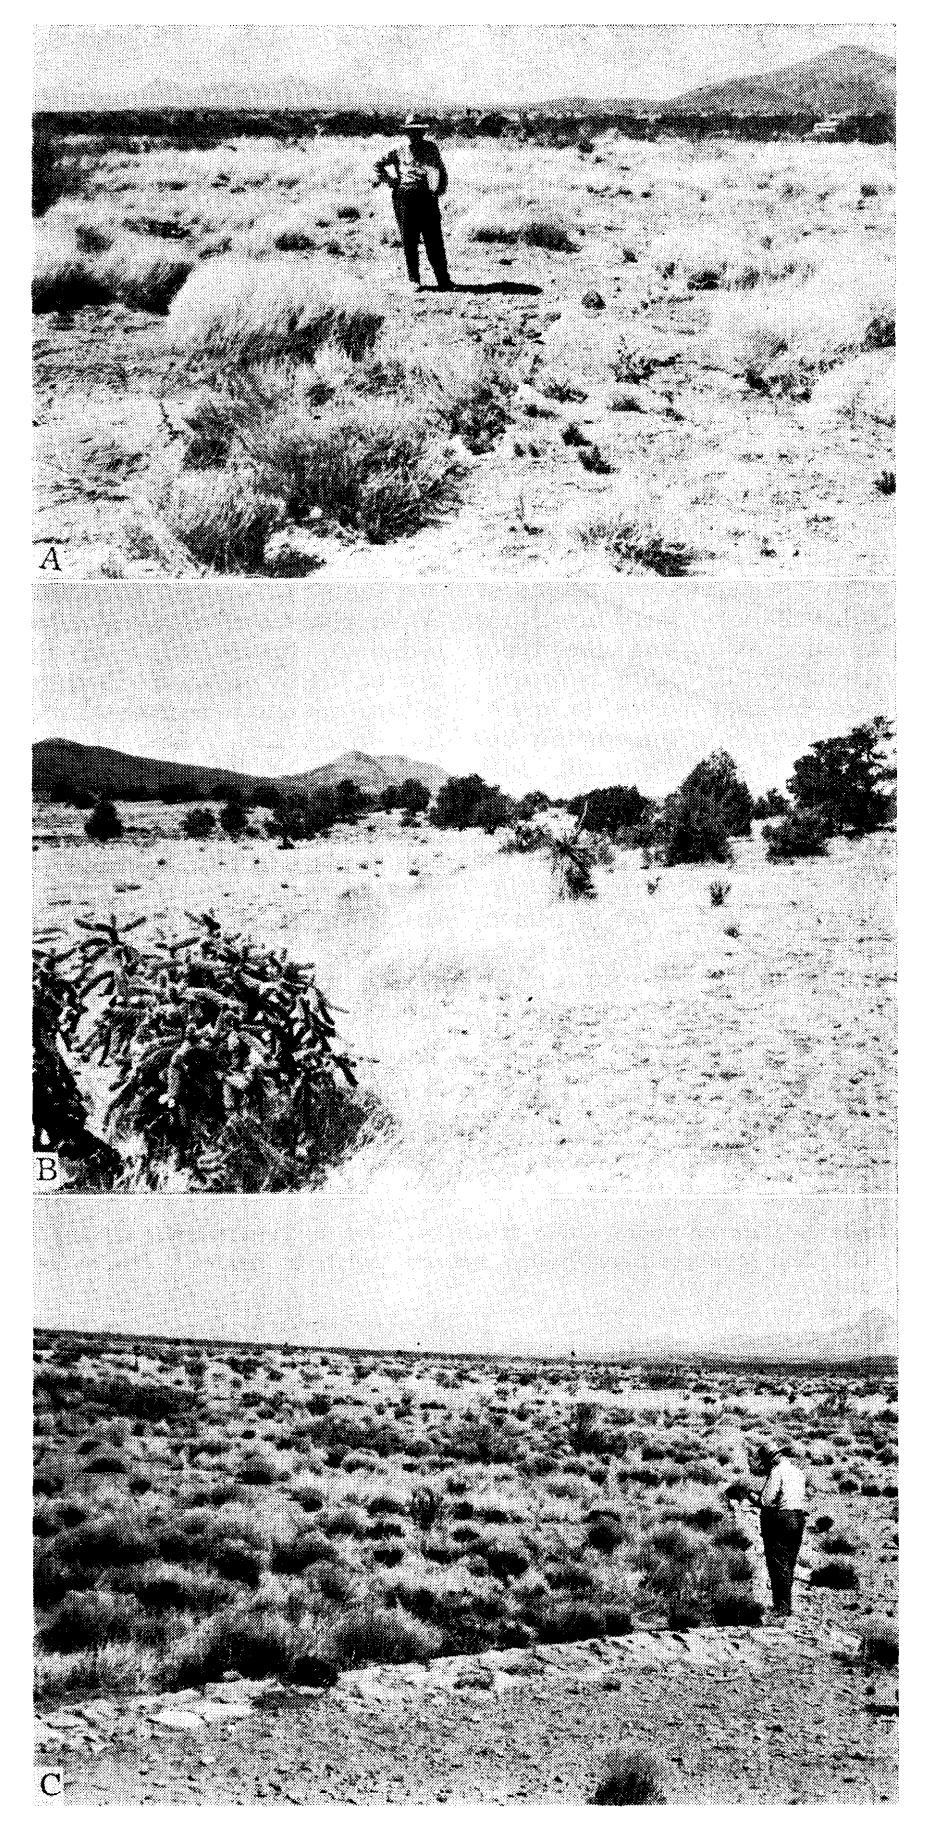
Conditions in 1961 showed some improvement o v er 1949 with regard to vegetation. In general the improvements were most pronounced where the structures still exerted some control on runoff and plants received e x tra water through spreading or impounding. Best results were achieved in the areas of higher elevation (Silver City, Rodeo, and Whitlock Valley), but some local improvement was also evident at FreeFIGURE 3. A. Buried rock spreader with good growth of tobosa grass in overlying sediment. Whitlock Valley, 1961. (Previous page)

- B. Excellent recovery of range grass at rock spreader. Silver City, 1961.
- C. Well defined effect of rock spreader on tobosa grass. Rodeo area, 1961.

man Flat and Indian Gardens. Figure 3-A shows the recent growth in part of the spread area in Whitlock Valley. Figures 3-B and C show similar improved conditions in parts of the Silver City and Rodeo areas, respectively. In 1949 each of these areas was almost barren. Figure 4 shows the conditions on one of the spreaders in Indian Gardens in 1961 (view A) as contrasted with an adjacent area where spreaders had not been constructed (view B). Figure 4-A shows the same area as Figure 1-A, taken in 1949.

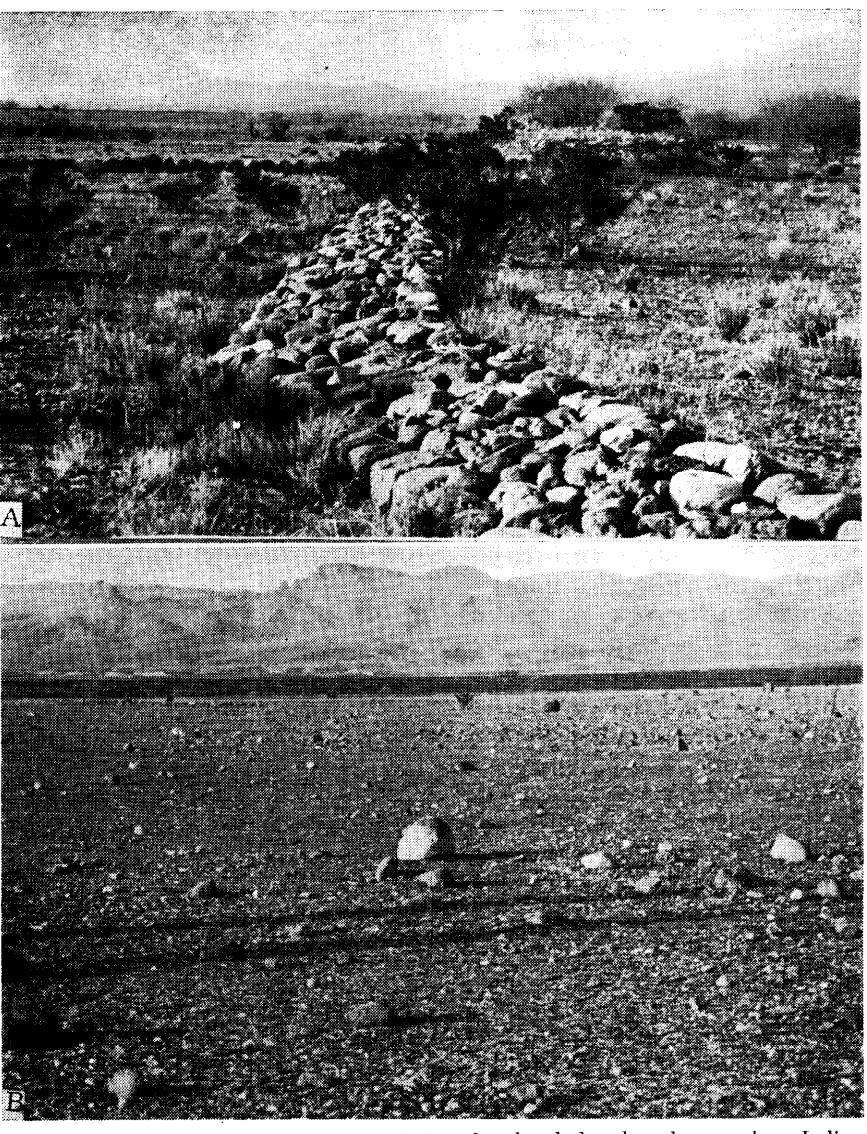
FIGURE 4. A. Vegetative recovery in vicinity of a hand-placed rock spreader. Indian Gardens, 1961. Compare with 1-A, approximately the same locality in 1949.
B. Shows very sparse vegetation below spread area. Indian Gardens, 1961.

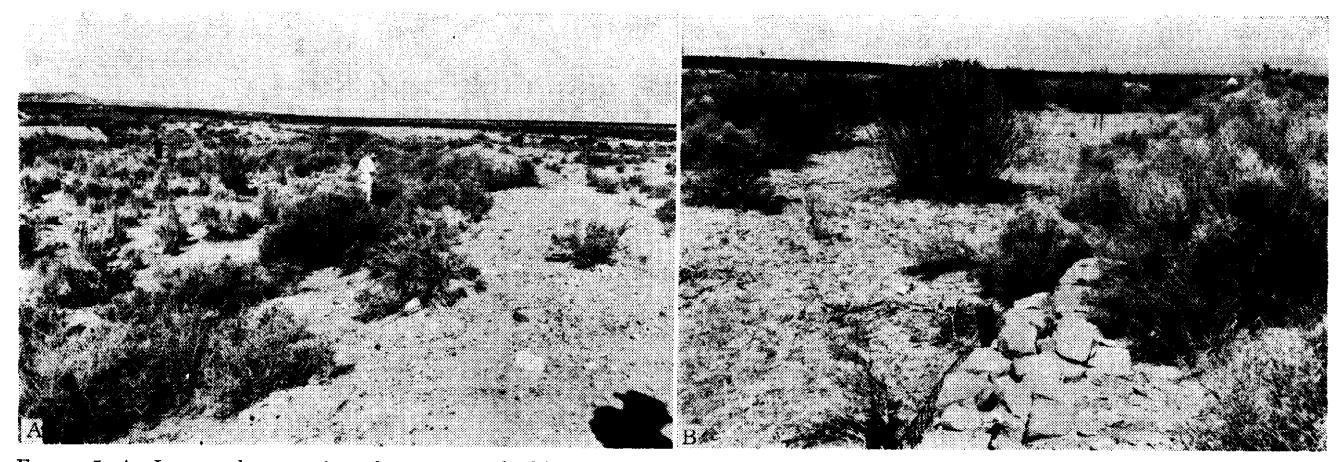
FIGURE 5. A. Increased vegetation above an earth dike. Freeman Flat, 1961. Locality gets some additional water from upstream sources. The grass to the left is alkali sacaton.

B. Seep-willow growing above dike where water has been ponded for long periods. Freeman Flat, 1961.
