# Mule Deer Responses to Deer Guards

DALE F. REED, THOMAS M. POJAR, AND THOMAS N. WOODARD

**Highlight:** In this investigation the effectiveness of guards 12, 18, and 24 feet long in preventing mule deer from crossing vehicle openings in fences 8 feet high was evaluated. The guards were constructed of flat mill steel rails  $\frac{1}{2} \times 4 \times 120$  inches, and were tested under both controlled and field conditions. Under controlled tests, 16 of 18 deer successfully crossed the guard. Fifteen deer and one elk crossed guards under field conditions. Deer did not attempt wide jumps over the guards, but rather walked, trotted, or bounded across them. Use of this guard type under the condition tested is not recommended.

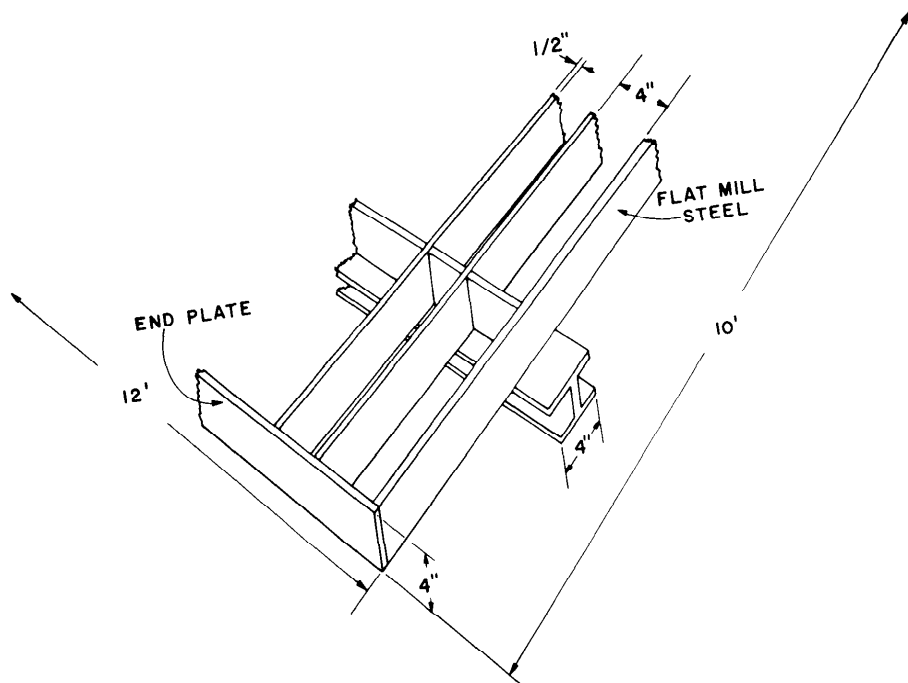
Fig. 1. Modified deer-cattle guard specifications.

Land Management wildlife enclosure fence at Trail Gulch between Dotsero and Burns, Colo. Both guards utilized 10 x 12 ft sections (Fig. 1) constructed with flat mill steel  $\frac{1}{2} \times 4 \times 120$ -inch (width, height, and length, respectively). The flat mill steel rails were perpendicular to the direction of traffic. The lengths of guard tested, 12, 18, and 24 ft, were measured parallel to the direction of traffic flow. The guard at Trail Gulch was used for controlled tests, while both were monitored for deer use under field conditions.

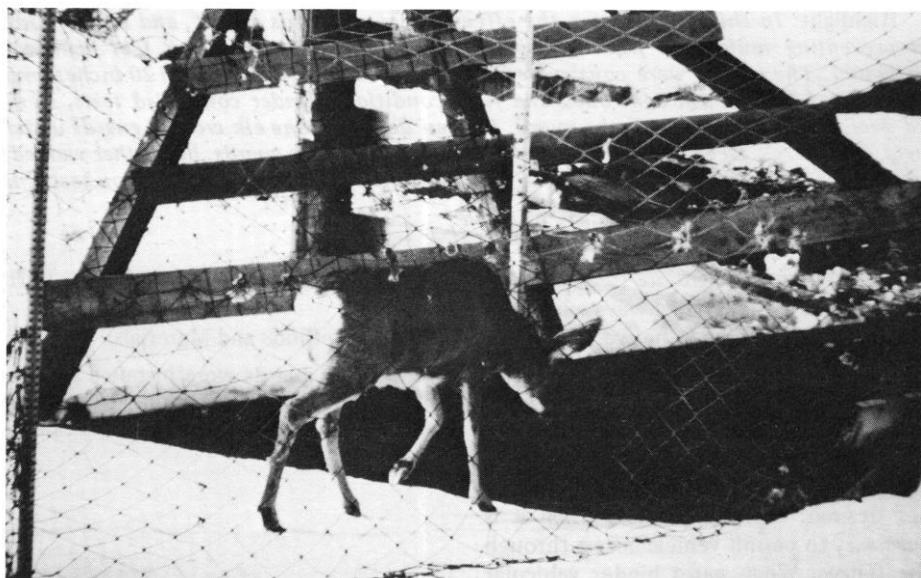
Fig. 2. Test deer Number 15 spent 84 seconds from release to having completed a crossing of the guard. During this time the animal completed three instances of investigative behavior, one of which is shown.

Sixteen of the 18 test deer crossed the structures (Table 1). The mean ( $\pm S$ ) time from release to crossing was 172.6 ( $\pm 274$ ) seconds. The range of 11 to 1017 seconds was indicative of the variable responses observed (Fig. 2).

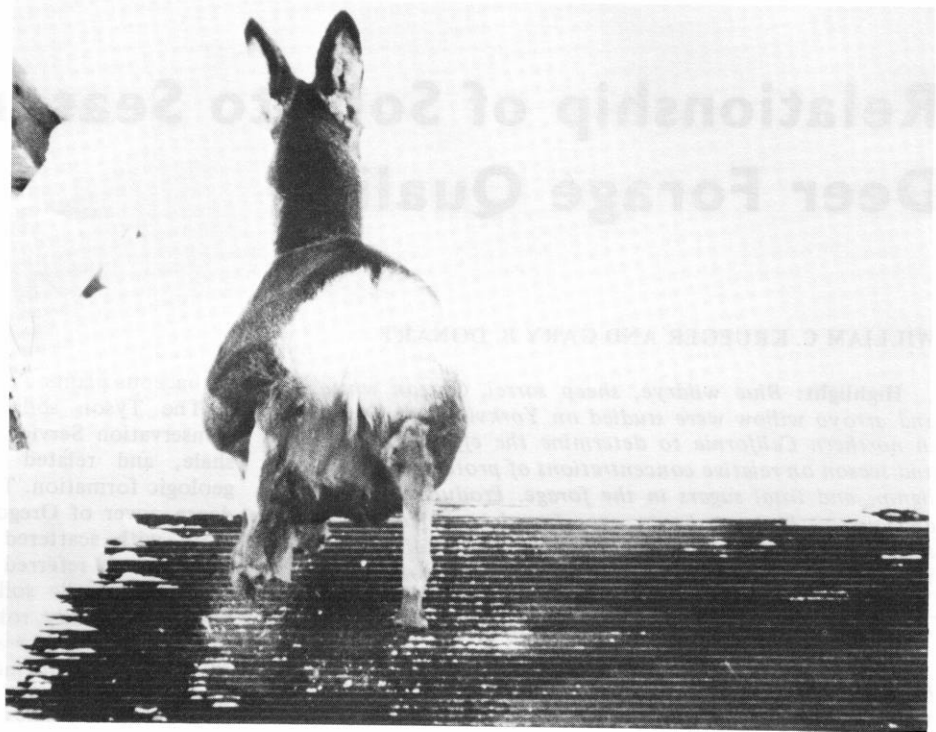
**Fig. 3.** Dew claws may have prevented this deer from slipping into the guard. The dew claws on the right back leg appear to be spread and in contact with one of the guard rails.

Four of the 14 deer that crossed the 12- and 18-ft guards fell through the steel railings with all four legs. None of these animals were seriously injured. Their predominant response was to roll onto their sides, thereby getting their hooves onto the rails again. Apparently the dew claws prevented the animals from falling through more frequently (Fig. 3).
