# Water Catchments on the Fort Apache Indian Reservation

Gary W. Frasier and Sherri L. Simper

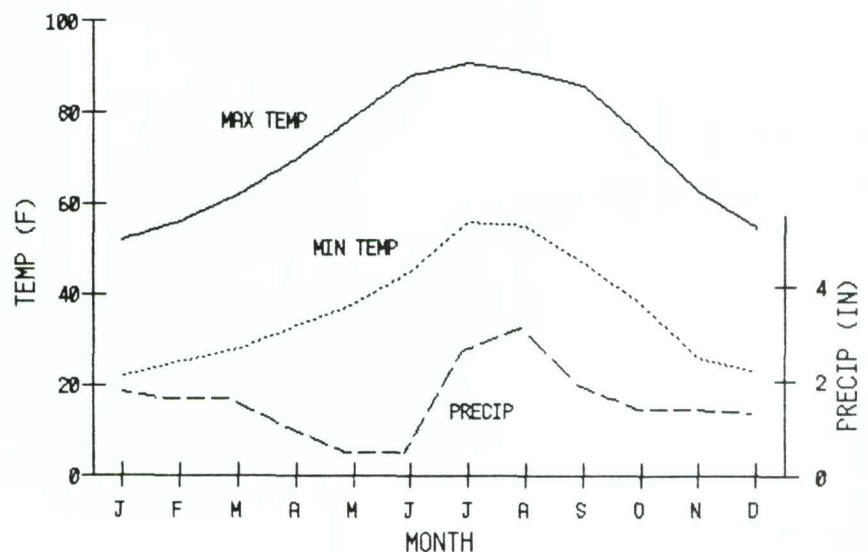
Monthly temperature and precipitation

considered mild with a mean annual precipitation of approximately 18 inches. The surface soil was derived from decomposed granite and classified as a clay loam with 36% clay, 26% silt and 38% sand. The soil cracks upon drying, forming sand sized aggregates from the fine soil particles (clay and silt).

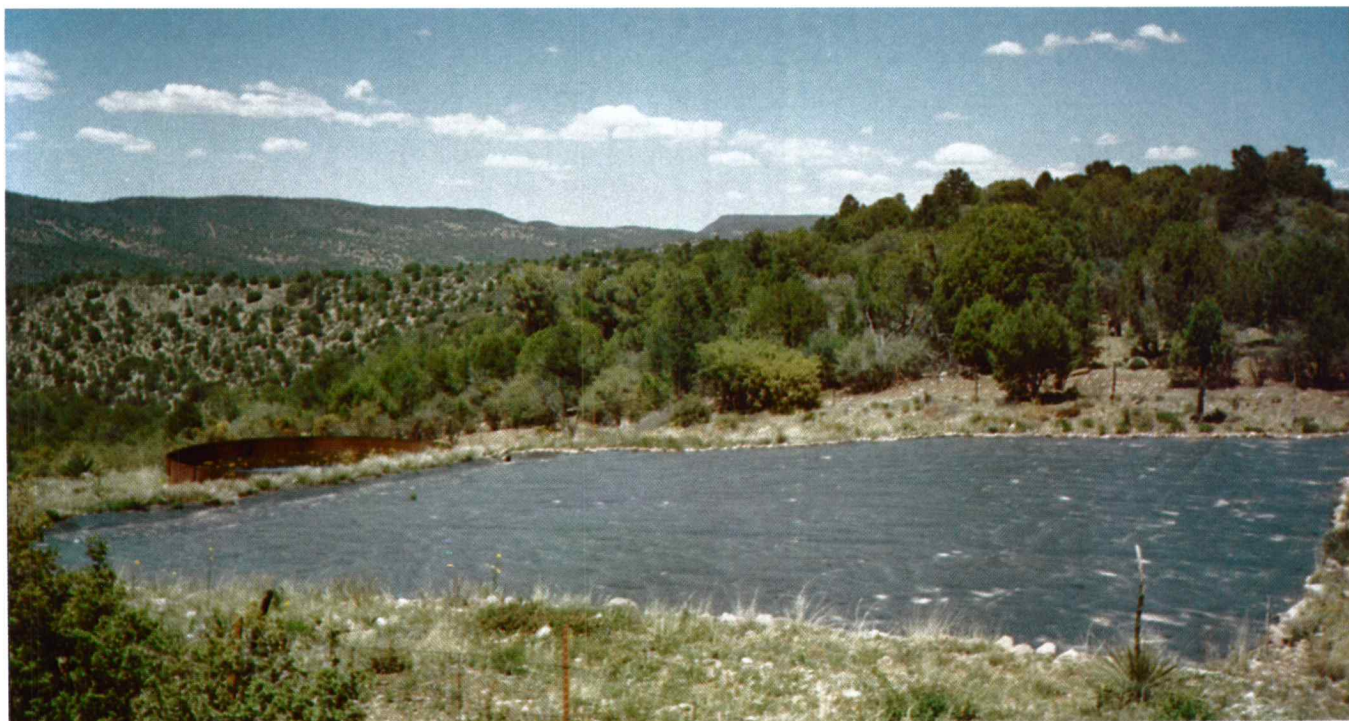
*Mescal water harvesting catchment.*

area approximately  $94 \times 94$  feet on a 10% slope was cleared with a bulldozer. After clearing, the area was hand raked to remove rocks and treated with a soil sterilant. The cleared area was covered with a 20-mil thick sheeting of chlorinated polyethylene. Twenty foot wide strips of the sheeting were unrolled on the soil surface and the edges bonded together with a petroleum solvent. The outside edges of the sheeting were anchored at the berms of the catchment area.

Water collected from the catchment area drains to one corner and into a 40,000 gal steel-rim tank set into a circular concrete base. The tank bottom is sealed with a 22 mil thick vinyl sheeting bonded to the tank rim. A pipe leads from the storage tank to a drinking trough outside the enclosing fence. The system supplies water to approximately 60 cattle winter grazing the surrounding rangelands. Various wildlife use the facility on a year-round basis.
