# A Case Study in Woodland Restoration

Susan E. Boettcher, W. Carter Johnson, and F. Robert Gartner

## A Brief History of the Mortenson Ranch

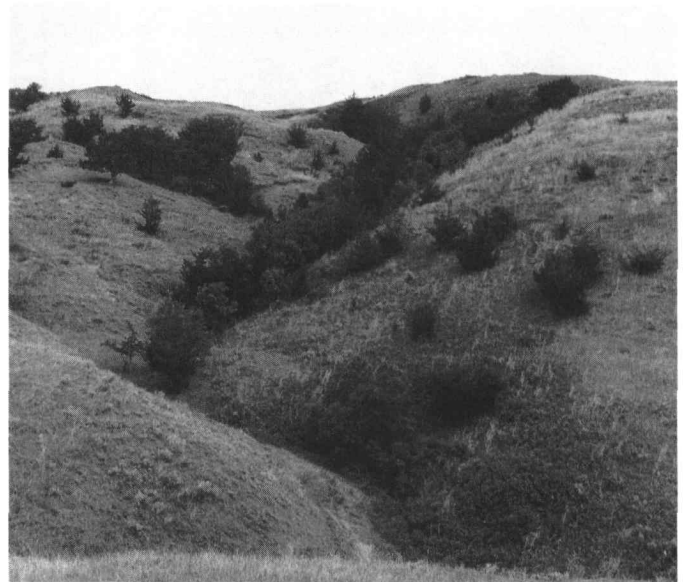
*The west-facing site overlooking the Cheyenne River floodplain. Most trees on side slopes are Rocky Mountain juniper.*

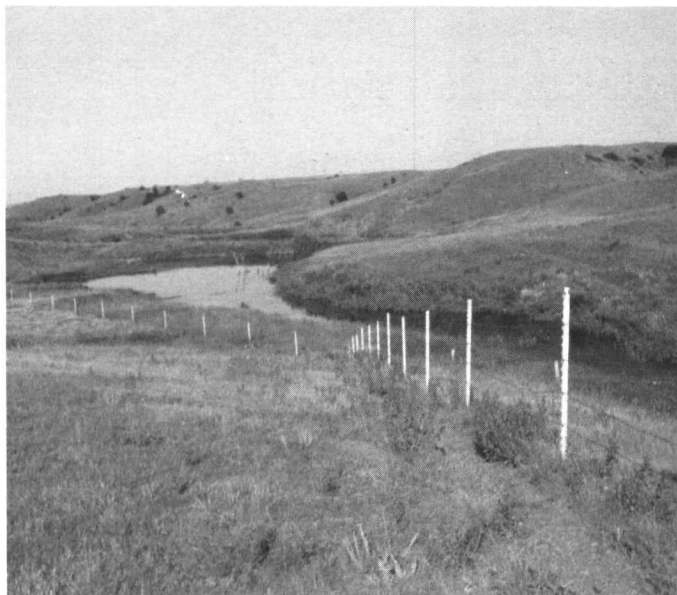
A. Photo taken in 1983 on the Mortenson ranch. Photo by Clarence Mortenson.

A series of "speed-bump" dams designed and built by Clarence Mortenson slows the flow of intermittent streams

after snowmelt and high-intensity rainfall. Water now spreads over the floodplain, percolating into the soil and replenishing the water table. The floodplain accumulates sediment, rebuilds the surface, and renews streamside aquifers. As a result, trees and shrubs have become established and are able to survive in years of relatively sparse rainfall.

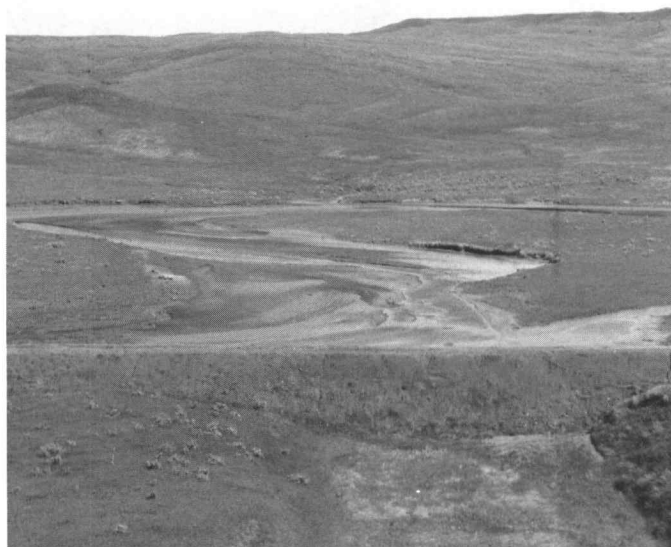
C. An unusual 4-inch rain occurred just after this dam was built in 1986. Photo by Clarence Mortenson.

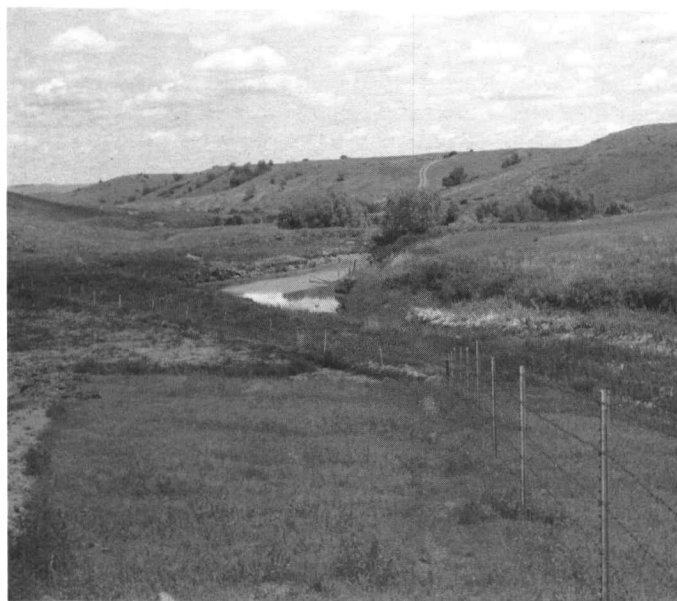
B. The same view as above in 1992. Compare the size of the trees at photo's center with those in the previous photo. Photo by Clarence Mortenson.

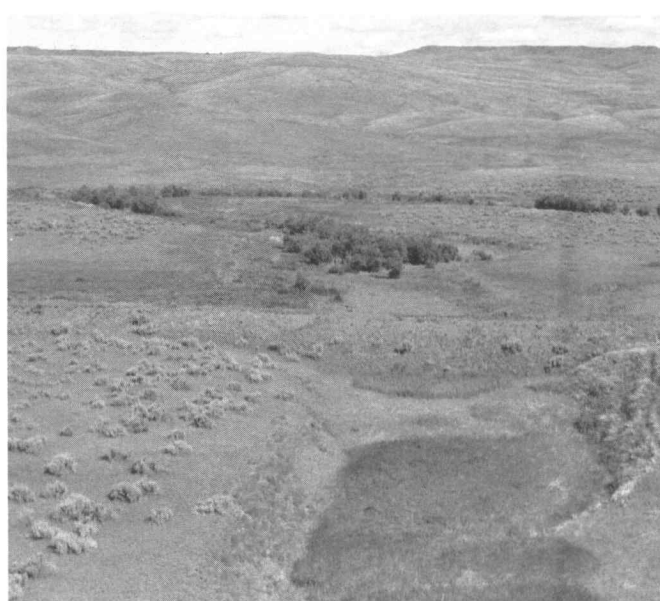
D. The same view as above in 1992. Note establishment of trees. Photo by Clarence Mortenson.
